PdM Solutions of San Antonio, Inc

Vibration Analysis Cover Sheet

Plant	XXXXXXX	Location.	San Antonio, TX
Contract No.	XXXXXXX	Date	XXXXXX
Unit ID#	HS#4 600HP	Refrigerant	NH3
Compressor Model	RECO/Mycom 250LUD-MX S/N:XXXXXXX		
Suction Press/temp.	23.5 psig / 0 F	Discharge Press/temp	165 psig/ 169 F
Type of Oil Cooling	TSOC	Oil Press/temp.	33.5 psig/ 102 F
Oil Injection	100 %	Compressor Load	100 %
Type of Oil	FES #1	Compressor Vi	3.6
Compressor Run Hour	36540(Run 278 Hrs)	Compressor speed	3550
Driven by	Motor	Driver Gear	N/A
Pinion Gear	N/A	Motor manufacturer	XXXXXX
Motor BHP	600 HP	Motor S/N	XXXXXX
Motor Bearing-Drive	6316C3	Motor Bearing-Open	6316C3
Service History	6/15/99:Changed motor bearings at 18053 hrs. 9/5/00:Replace motor to Toshiba. 10/22/01:Alignment check done by PdM Solutions. 11/12/2004:Alignment check by PdM Solution.		
Data Taken by	XXX/PdM Solutions	Data Analyses by	XXX/PdM Solutions

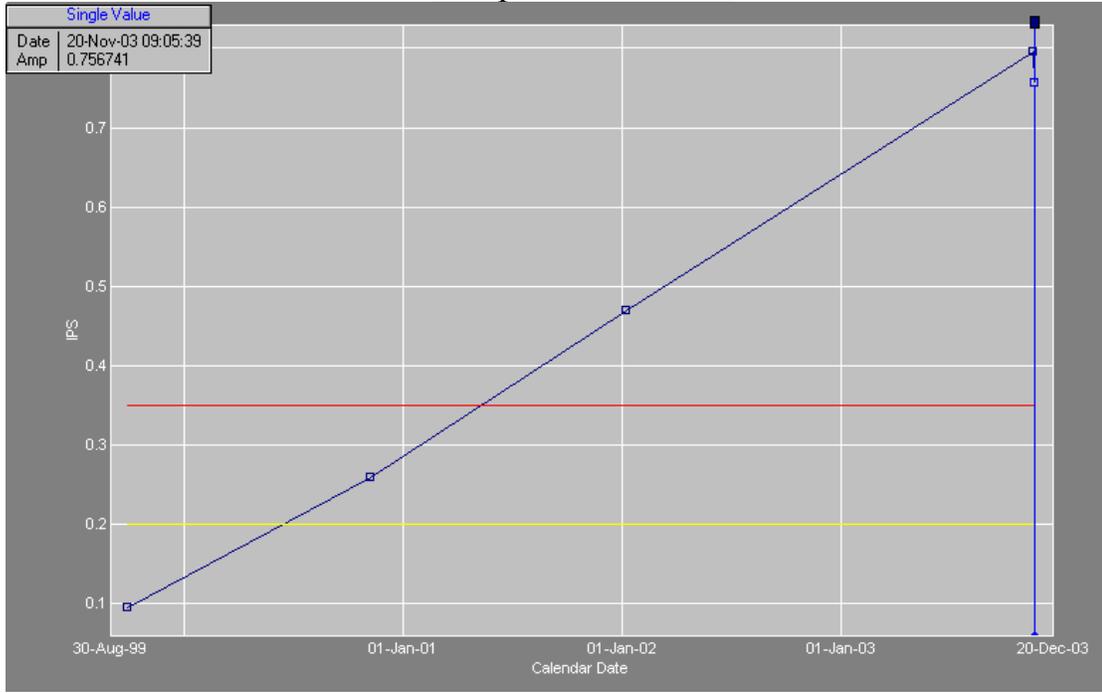
Sample Trend Chart

Compressor's thrust bearing damage detected. It is probably outer race. Recommendation should be made to prepare for service. Expect bearing life left +/- 6 months.
Also high vibration existed on the compressor's discharge piping due to installation stress.

- A) Last measurement report
- B) Vibration trend (Acceleration) at discharge bearing heads (male and female rotor side)

Prepare for compressor service (Thrust bearing replacement.)
